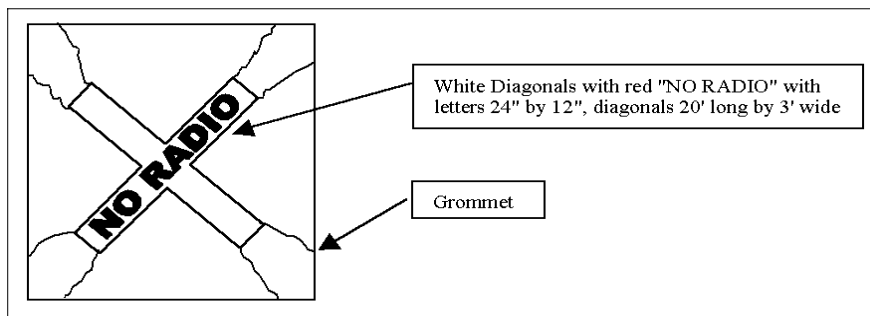
FIG 10-2-1
Closed Helideck Marking – No Radio

(2) Close the deck and make the radio warning clearly visible to passing pilots, install a temporary marking (described in subparagraph 10-2-1i1(b)) with the words “NO RADIO” stenciled in red on the legs of the diagonals. The letters should be 24 inches high and 12 inches wide. (See FIG 10-2-1.)

(1) Pilots when operating within 1,000 feet of a known perforation operation or observing the white X with red “NO RADIO” warning indicating perforation operations are underway will avoid radio transmissions from or near the helideck (within 1,000 feet) and will not land on the deck if the X is present. In addition to communications radios, radio transmissions are also emitted by aircraft radar,
